Ref: FAQ0152

Title – SoundSens velocity crossed out

## SoundSens graphs – what the crossing out of distance values indicate

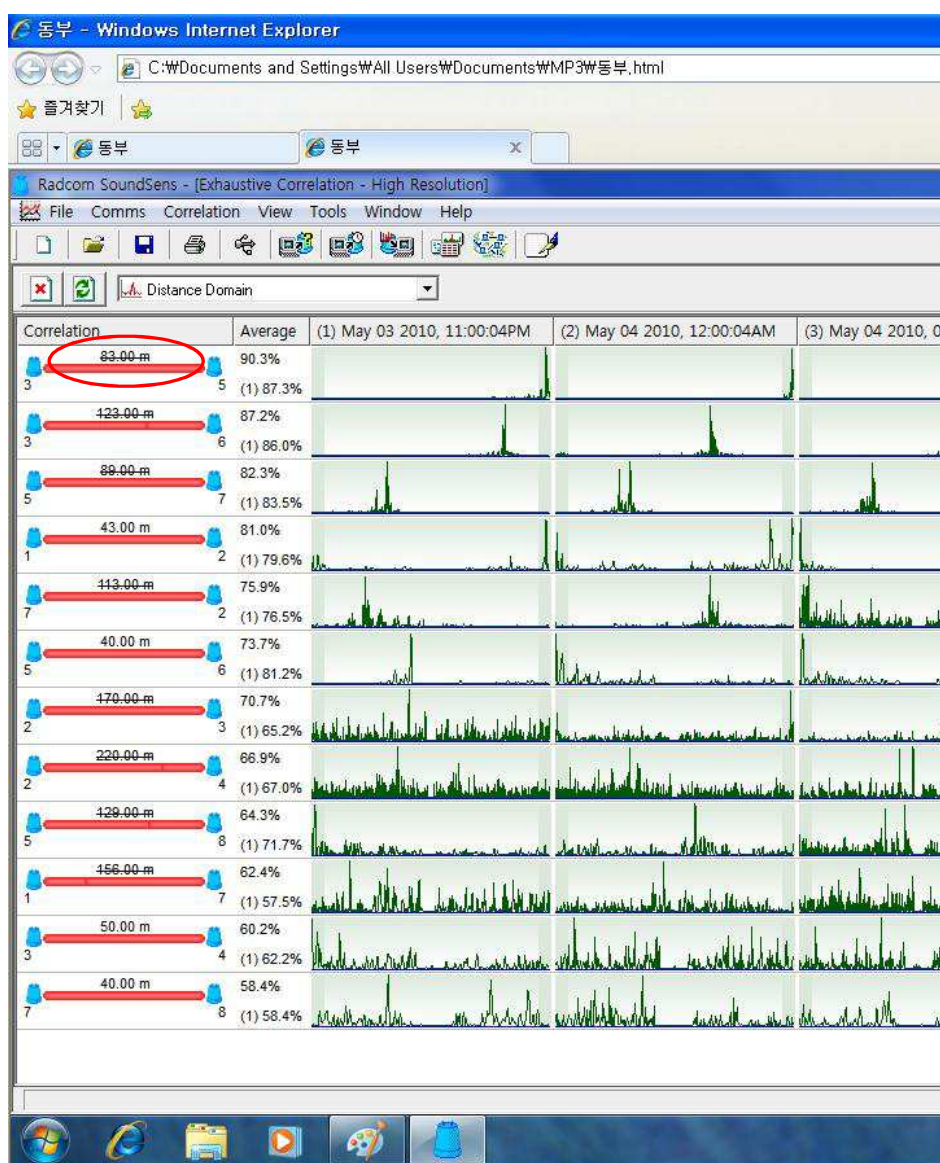
The 'crossed' lines through the distance reading on the graph is not a problem. It is the software identifying a warning to you. It indicates that there are 'multiple paths' in the pipe layout so the leak position is not definite. Basically before you start digging holes to find the leak you should try and localize it further with another test covering a smaller area of the pipe network.
