Use IDT Error when using Radterm - how to roll back to a firmware level which still supports Radterm

Downgrading logger firmware

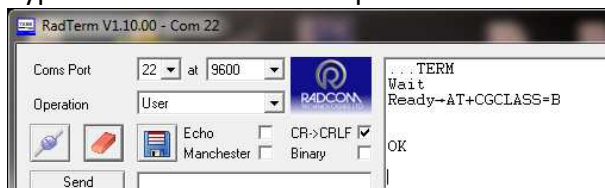
11. Type **AT+CGCLASS=B** then press Enter

12. The logger should respond “OK”

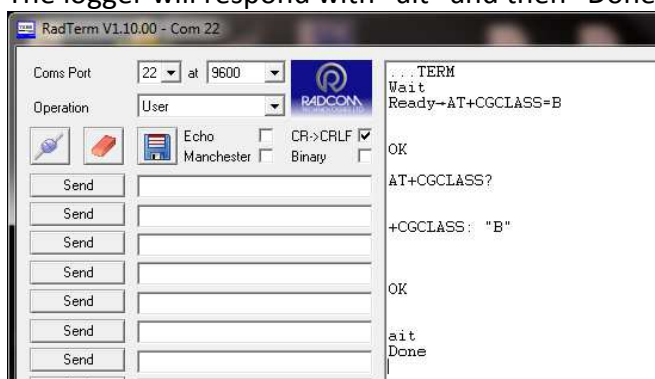
16. Press the “ESC” key

17. The logger will respond with “ait” and then “Done”
